Pipeline Intrusion Detections System for Guangdong Natural Gas Pipeline

CASE STUDY

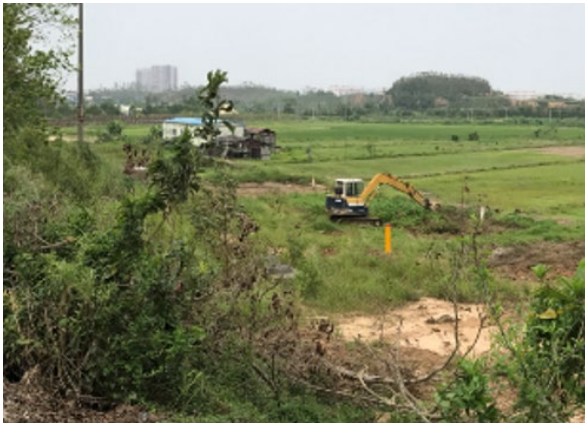
Photo of excavator near pipeline

Of the 87 verified events, there were a number of different scenarios. But on multiple times, there were cases where mechanical excavation equipment was close to or even above the pipeline.

Figure 6 - Photos taken by patrol on site post alarm

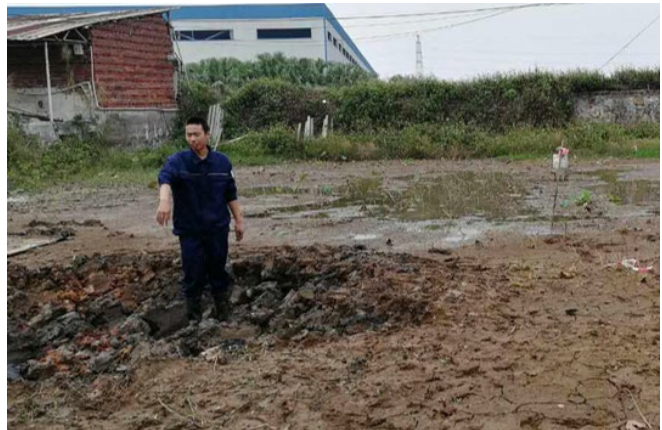
Photo of damage directly above pipeline

In one specific case, there was mechanical excavation activity directly above the pipeline. The excavator dug to a depth of 0.3m and damaged one of the control cables above the pipeline. The Horizon DAS alarmed and the patrol was deployed to the site before the machinery proceeded to the level of the pipeline (at a depth of 1.5m) and catastrophic damage was narrowly avoided.
